# **MUDDY CREEK FOLLOWUP PROJECT - 2005**

## **Final Report**

J. W. Bauder, Professor, and Kim Hershberger, Water Quality Associate  
Department of Land Resources and Environmental Sciences  
Montana State University Extension Water Quality

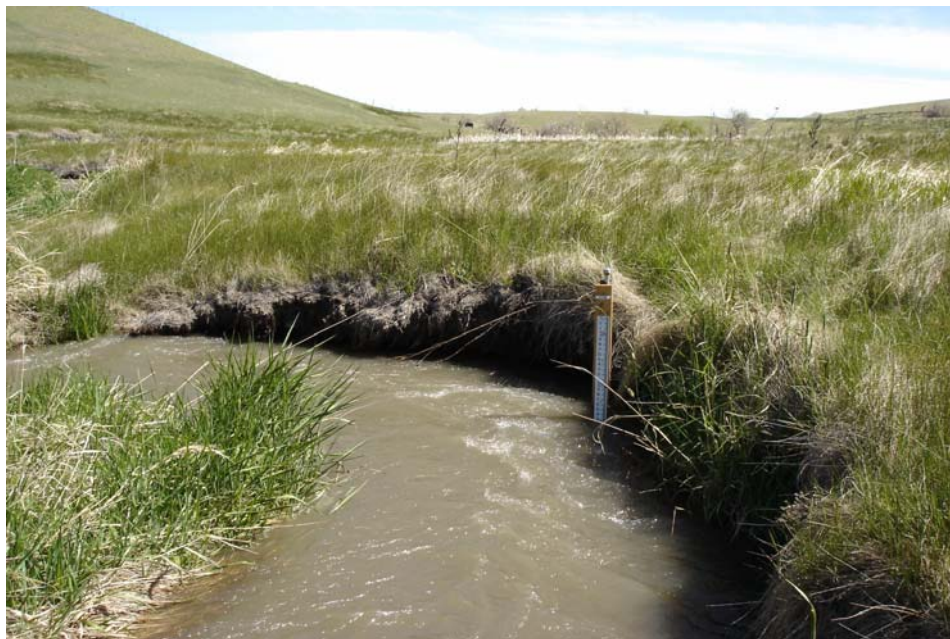
Creek below GS 51 EXT – May 31, 2005

On Tank Coulee, two new gauges were installed in addition to the gauges previously in place during the 2003 study. The gauge at Creek below GS 51 EXT helped to explain part of the large increases in flow between Middle and Lower Tank Coulee. The study also found that a large portion of the sediment measured in Tank Coulee is sourced between the MTC and LTC gauging stations. Any efforts to reduce sediment loads should be focused on this area of Tank Coulee.
